## HIGH POWER LED HEADLIGHT

Item Numbers: 35911/35912/35913/35914

### NORMAL FOGGING / CONDENSATION

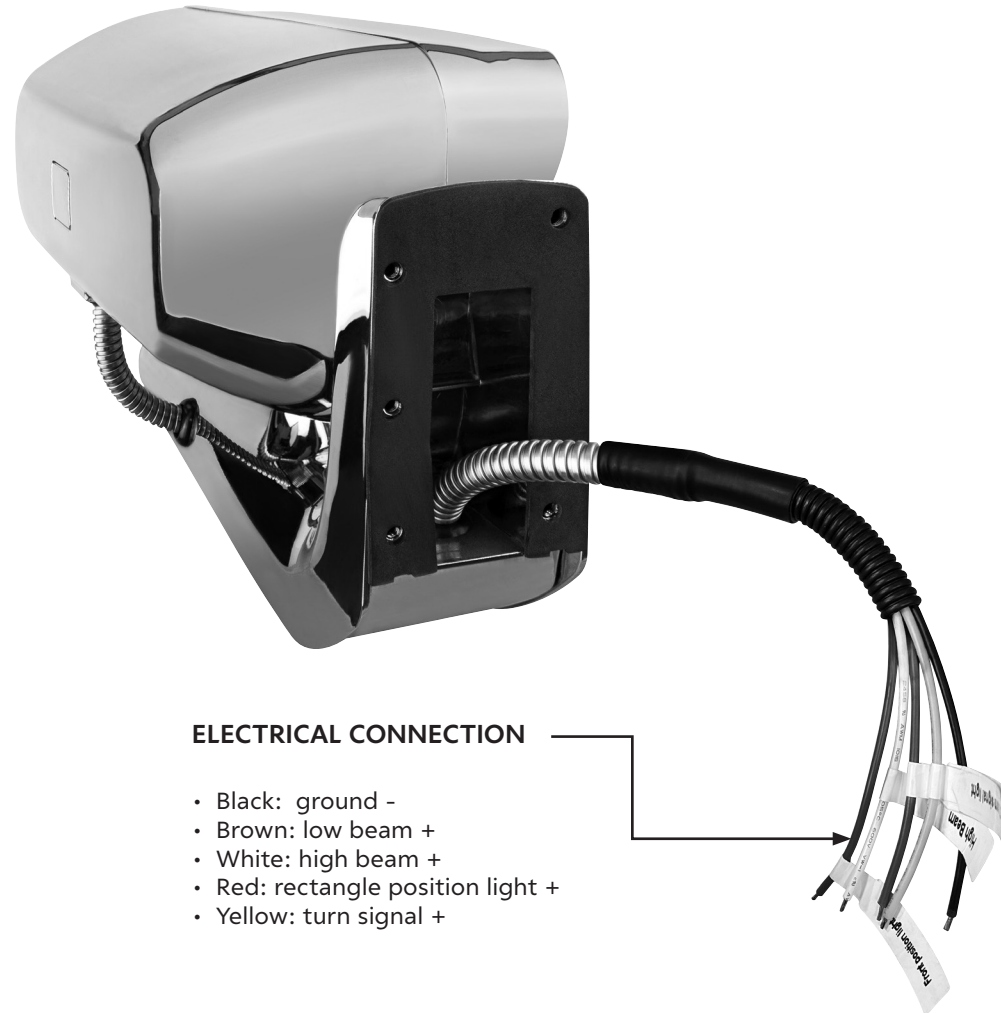
This bulletin provides information regarding headlights that may experience fogging or condensation inside of the headlamp assembly. A drop in air temperature may cause condensation to form on the inside of a cool headlamp lens. Generally, fogging is considered normal and can be eliminated by turning on the headlamp with the engine running for several minutes. In most cases, operating the vehicle in normal driving condition will clear the headlamp fogging. Headlamp assembly replacement **WILL NOT** be necessary in most cases.

- If any of the following conditions occur, please consult with a professional mechanic to determine the water source:
  - If condensation/fogging fails to dissipate after operating the headlight with the engine running for 30 minutes
  - If water pooled inside the headlamp
- A high pressure washer may also cause water to be forced into the headlamp assembly.
- Headlight does not have beam adjusters.
