## HIGH POWER 10 LED HEADLIGHT WITH 10 LED TURN & 100 LED HALO FOR 2008-2024 PETERBILT 389

Item Numbers: 32886 / 32887 / 32888 / 32889

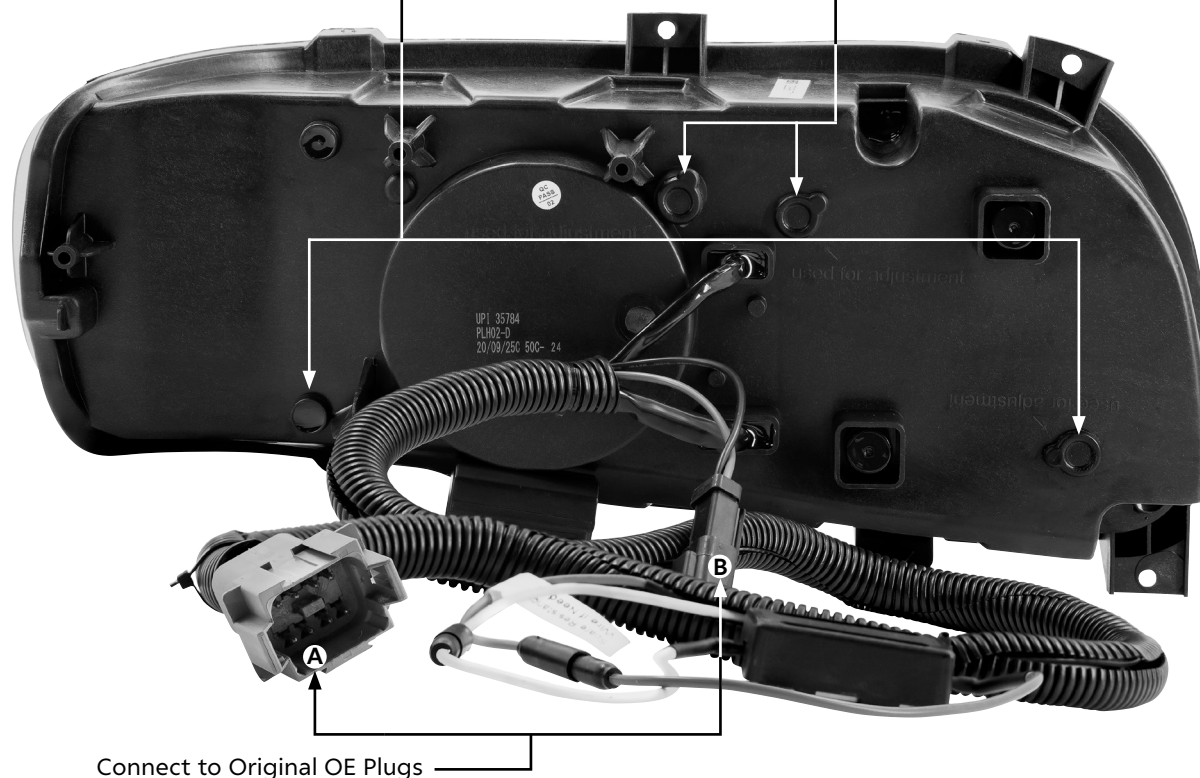
### Connect Plug A & B to Original OE Wire Harness

- A** 1. Turn Signal/LED Light Bar  
2. Low Beam  
3. High Beam
- B** Back Cover Turn Signal

**Low Beam Adjuster:**  
Clockwise = Beam UP  
Counterclockwise = Beam DOWN

**High Beam Adjuster:**  
Clockwise = Beam RIGHT  
Counterclockwise = Beam LEFT
