## HIGH POWER LED HEADLIGHT FOR 2008+ PETERBILT 389

Item Numbers: 36119/36120/36121/36122

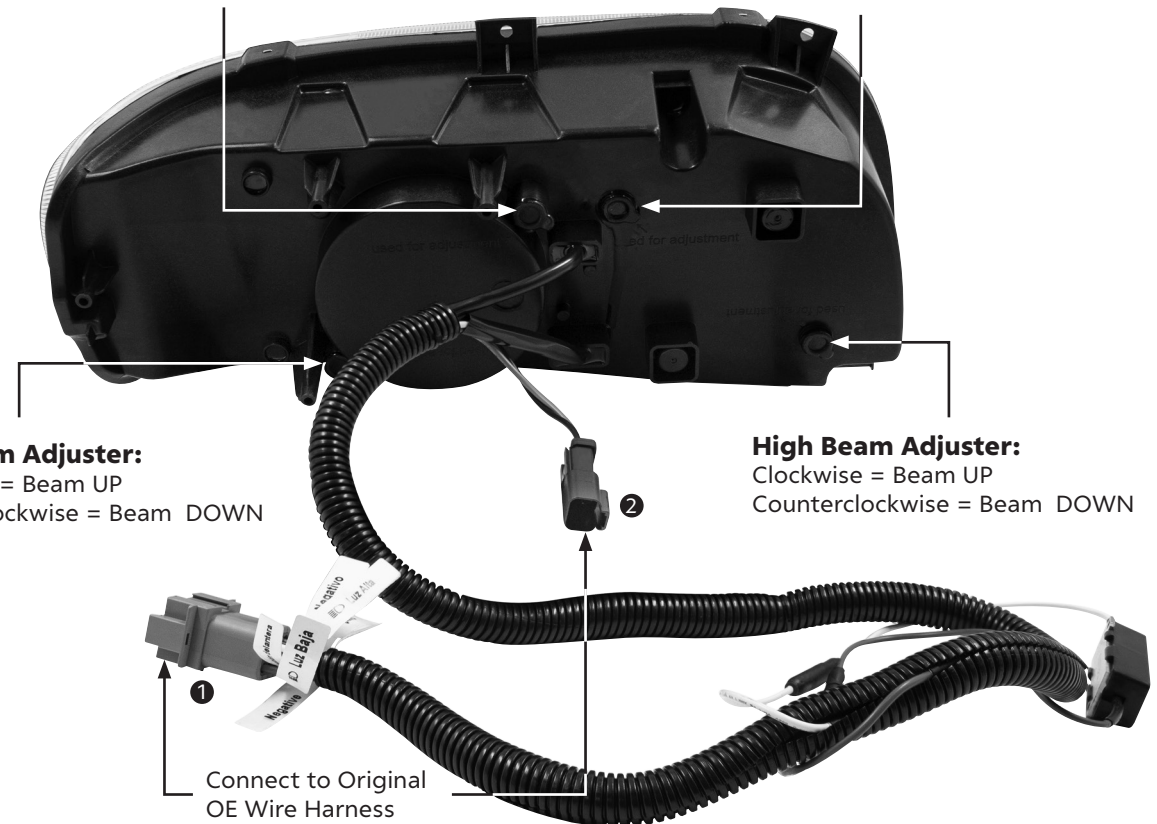
### Connect Plug ① ② to Original OE Wire Harness

- ① Turn signal / LED position light  
Low beam  
High beam
- ② Back cover turn signal

#### Low Beam Adjuster:

Clockwise = Beam LEFT  
Counterclockwise = Beam RIGHT

#### High Beam Adjuster:

Clockwise = Beam RIGHT  
Counterclockwise = Beam LEFT

Clockwise = Beam UP  
Counterclockwise = Beam DOWN
